SB: Wall mounted hose boxes rollup 15, 25, 35 and 35Li

Article : 8022, 8023, 8024 and 8025

Reason: Several improvements on the products since production start.

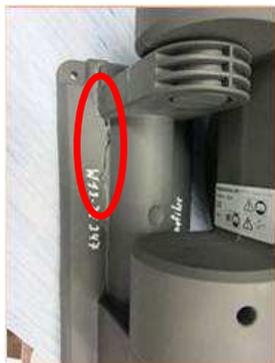
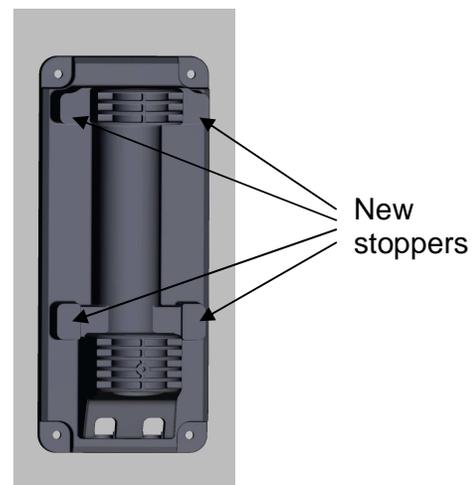
Issues on articles 8023, 8024 and 8025:

- Transport damages on wall holders: The wall holder will get 4 additional stoppers. The new version will be available in spring 2014
