SB: Wall - mounted hose boxes

Article : 8023, 8024, 8025

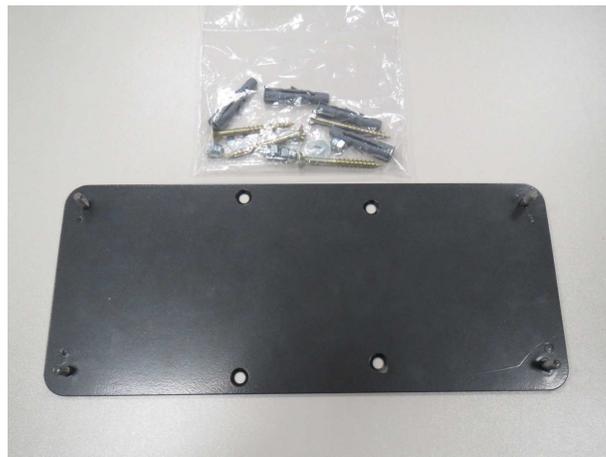
Reason: Incompatibility of the wall bracket hole pattern from the old models art. 2648 and 2656 to the new wall-mounted hose boxes:

Solution: The wall bracket art. 8023-00.900.03 has a different hole pattern compared to wall bracket 2648-00.600.21 . For service cases, when an old hose box art. 2648 or 2656 is changed into the new one (art. 8023, 8024 , 8025), an adapter plate is available to fix the bracket to the old holes :

The adapter plate with screws and dowels is available as a spare part with part no. 8023-00.650.06.
